Fort Leonard Wood – Building 2101

Interior Character-Defining Features, Inventory and Assessment

April 2014

Final report

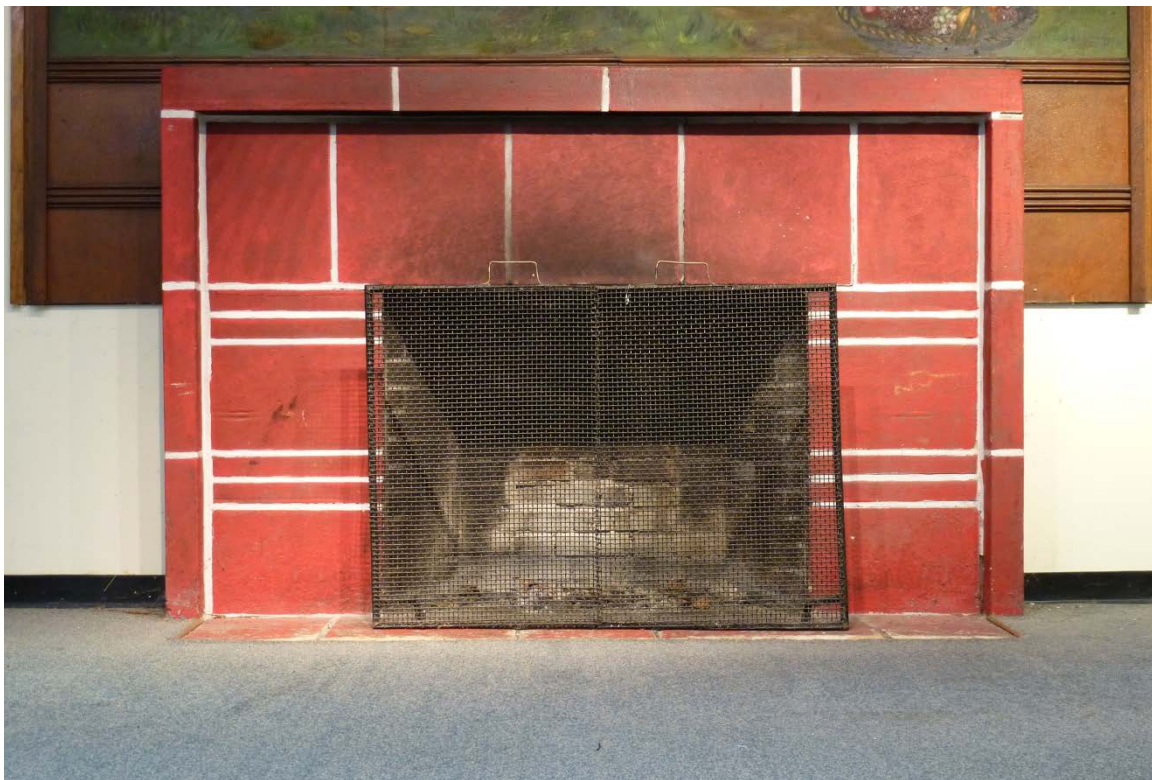
The stone fireplace on the main floor (Figure 30) was added to the building during summer 1945 by German prisoners of war (POWs) who were being held at FLW (US Army 1945). This fireplace is a primary character-defining feature of the building, along with the ell where it is located. This fireplace is heavily documented in the Building 2101 maintenance manual (Smith et al. 2005). In addition, a second stone fireplace was added to the building in the crawlspace when the chimney for the fireplace on the main floor was added (Figure 31). The second stone fireplace also is a character-defining feature.

Figure 30. German POW stonework fireplace on the main level. The red paint is not original, but it is unknown when the stone was painted (ERDC-CERL, 2013).

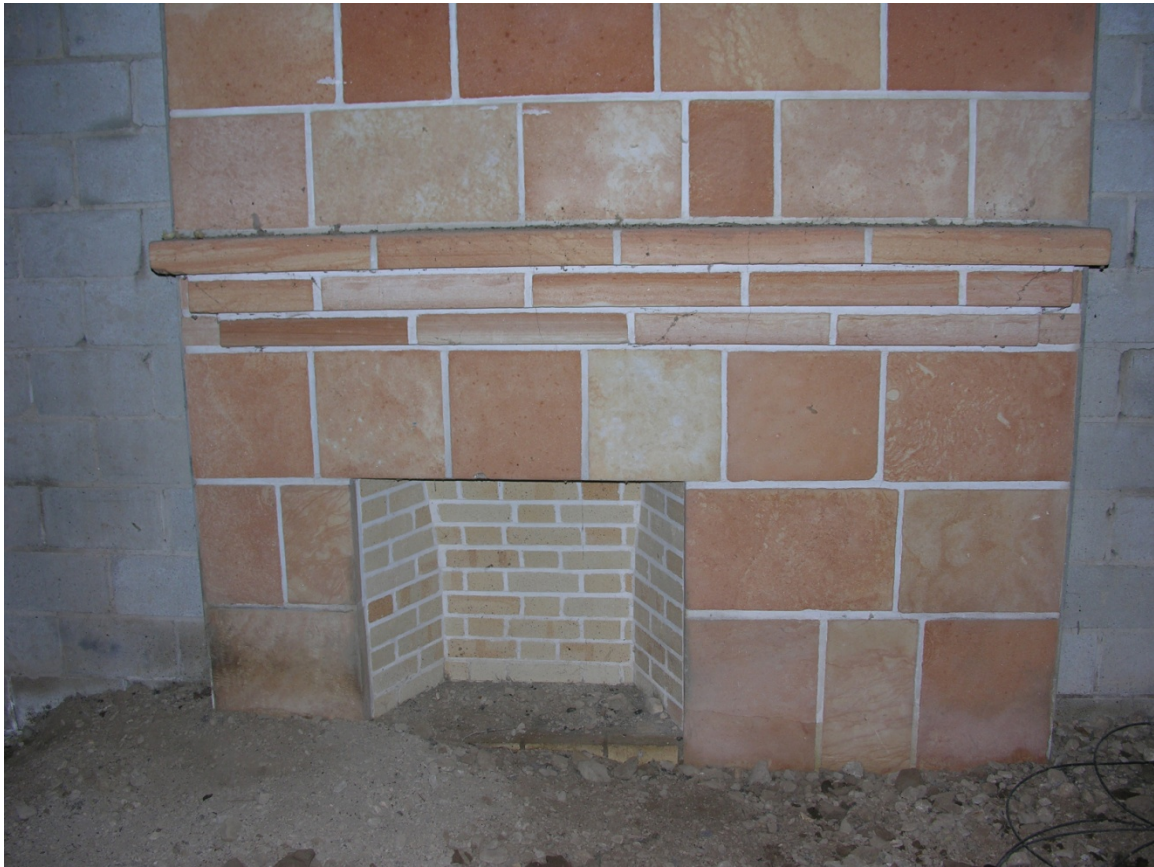
Figure 31. German POW stonework fireplace in the crawlspace (FLW, 2014).

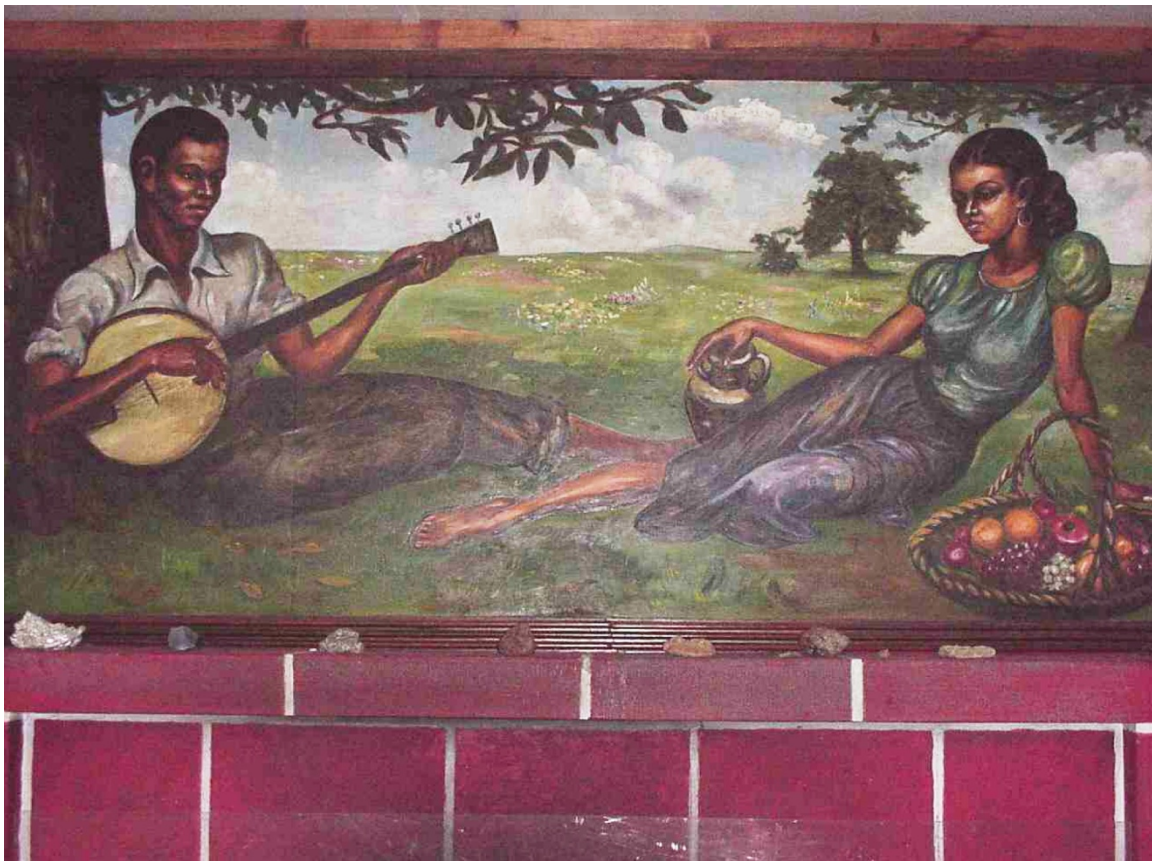
The mural was painted by Samuel Countee and placed above the German POW fireplace on the main floor in the summer of 1945 (Figure 32). It is a primary character-defining feature of the building.

Figure 32. Mural by Samuel Countee (ERDC-CERL, 2013).

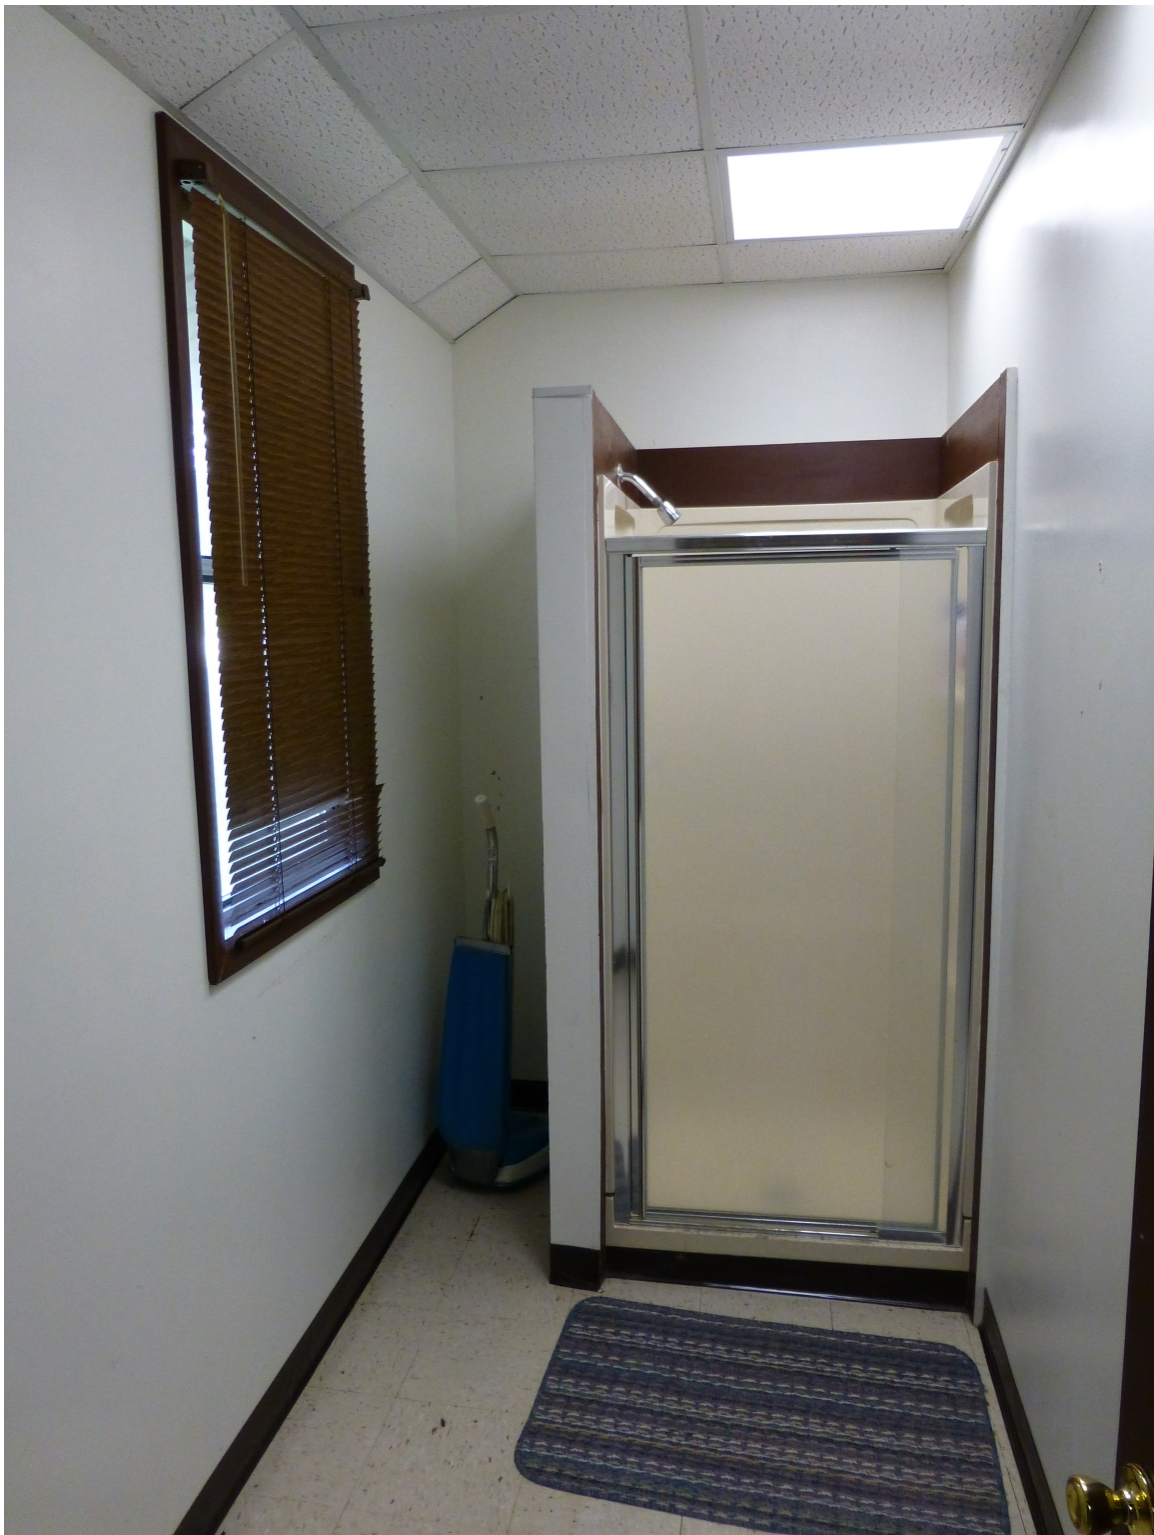
The shower in the southeast room is not original. The southeast room was originally the officers' toilet when it was an administration building; it is not known when its use was switched from restroom to shower room. The restroom in the southeast end of the building is original (Figure 33 and Figure 34), but most of the plumbing fixtures are not original except for the urinal (Figure 35).

Figure 33. Non-original shower in southeast room which was originally an officers' toilet during WWII (ERDC-CERL, 2013).

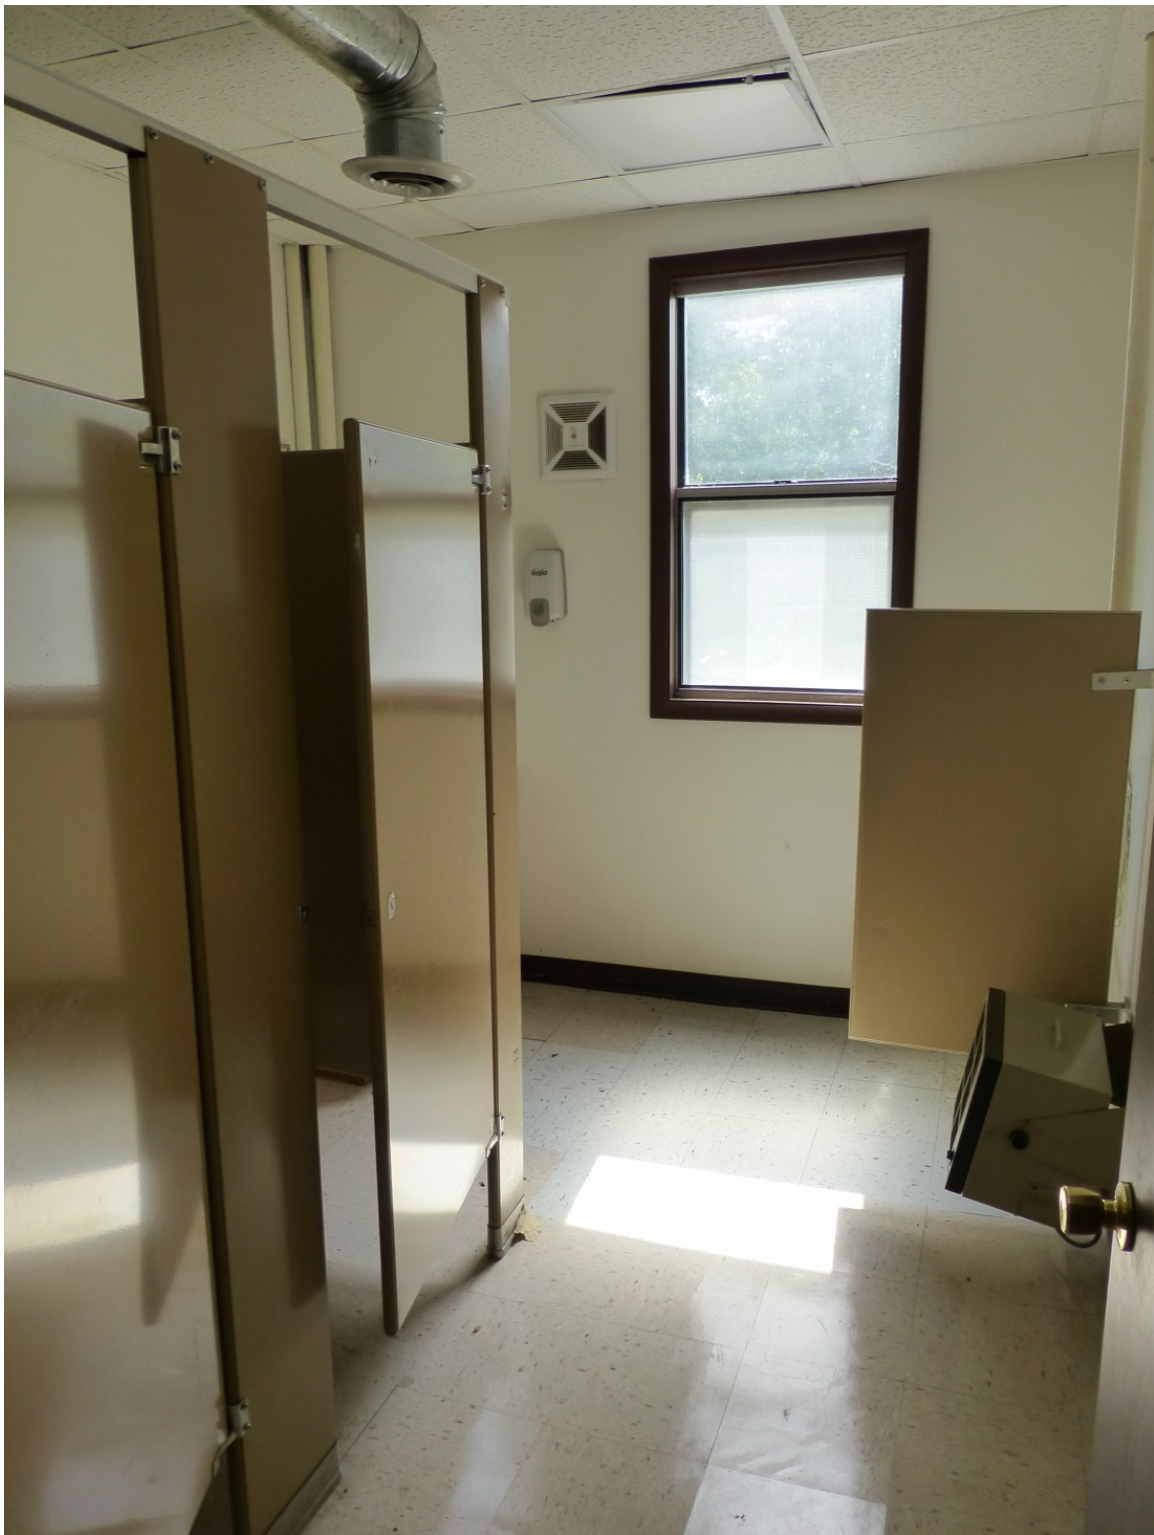
Figure 34. View of original restroom in southeast end of the building with non-original partitions (ERDC-CERL, 2013).

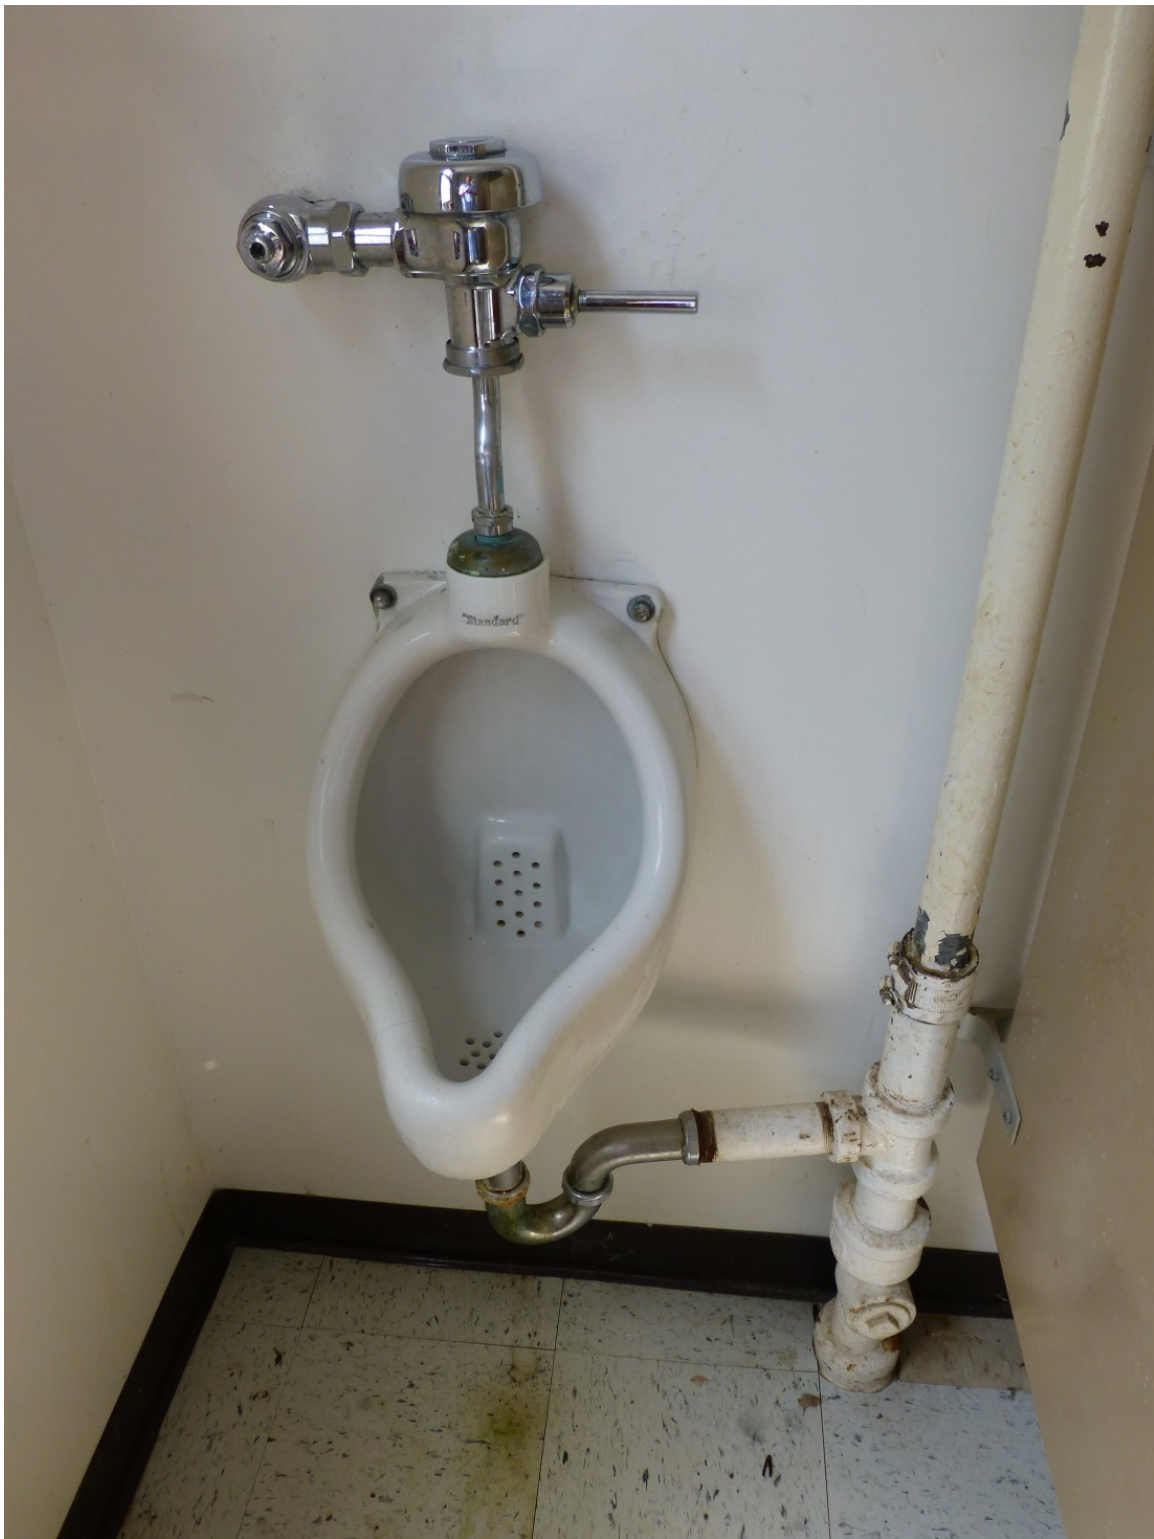
Figure 35. Original urinal in the restroom in the southeast end of the building with partitions (ERDC-CERL, 2013).

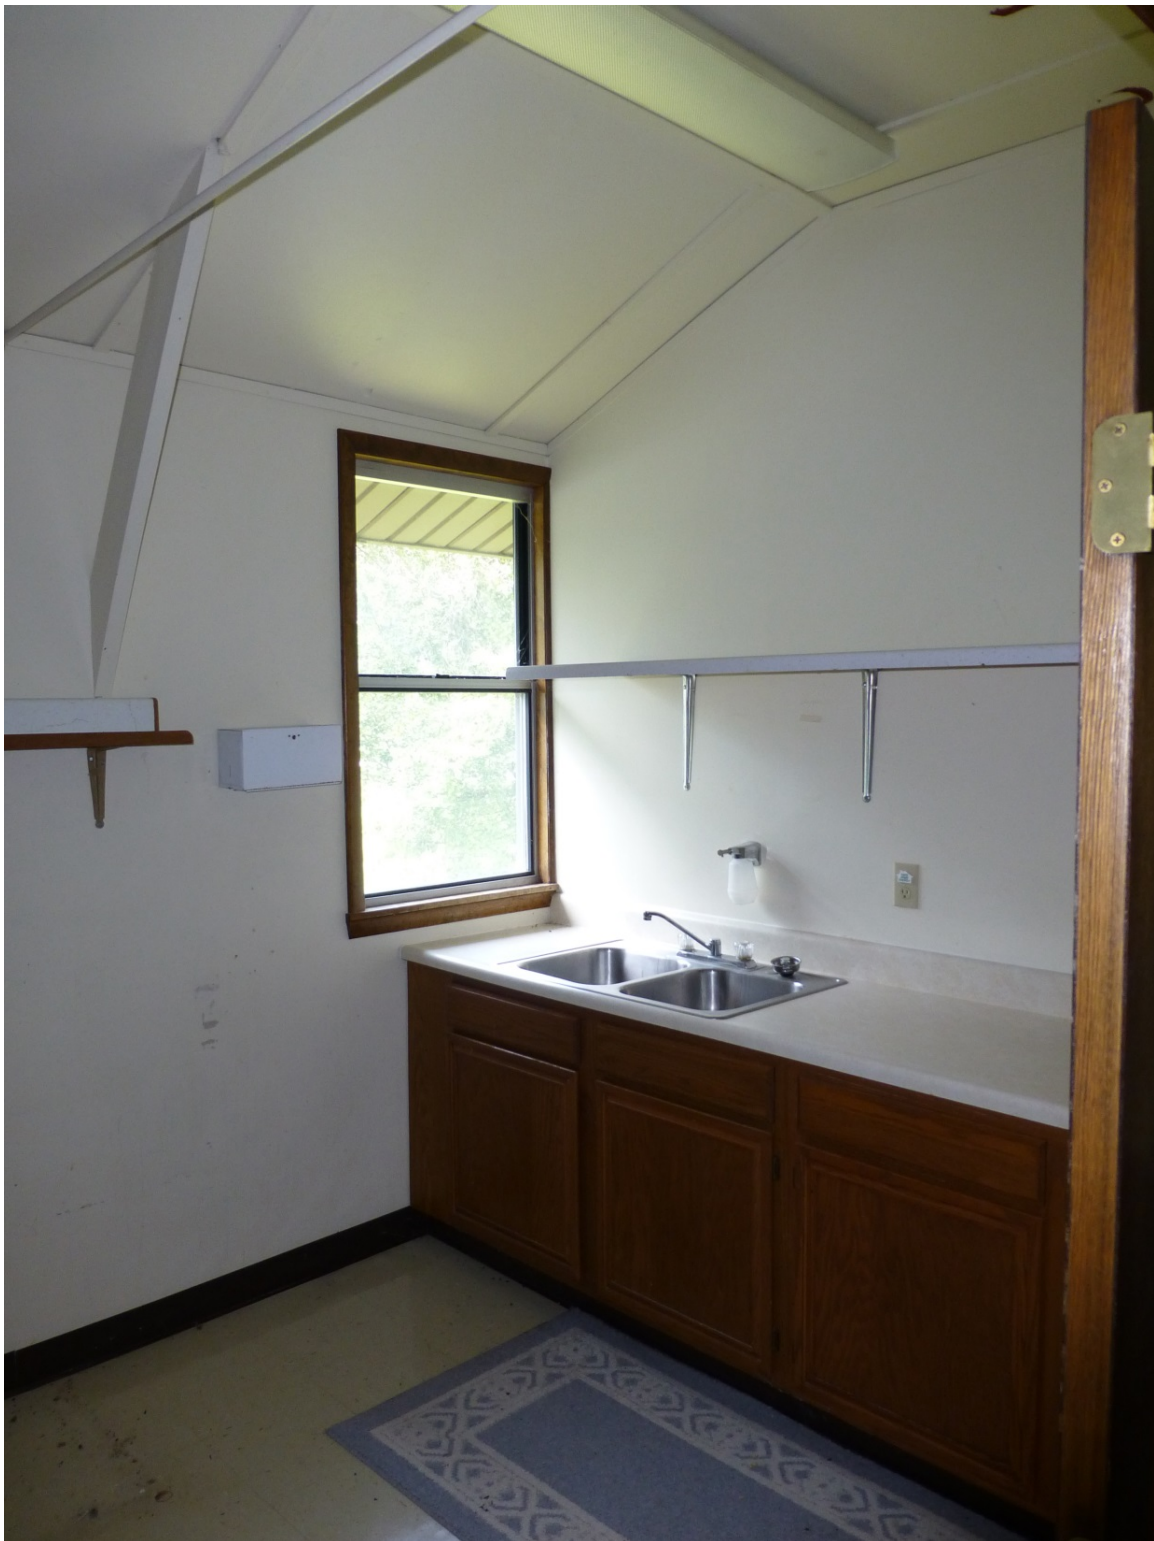
There is a kitchen and another restroom in the northwest portion of the building (Figure 36 and Figure 37). None of the plumbing fixtures in these two rooms are original.

Figure 36. Non-original kitchen with cabinets, sink, and shelf in the northwest portion of the building (ERDC-CERL, 2013).

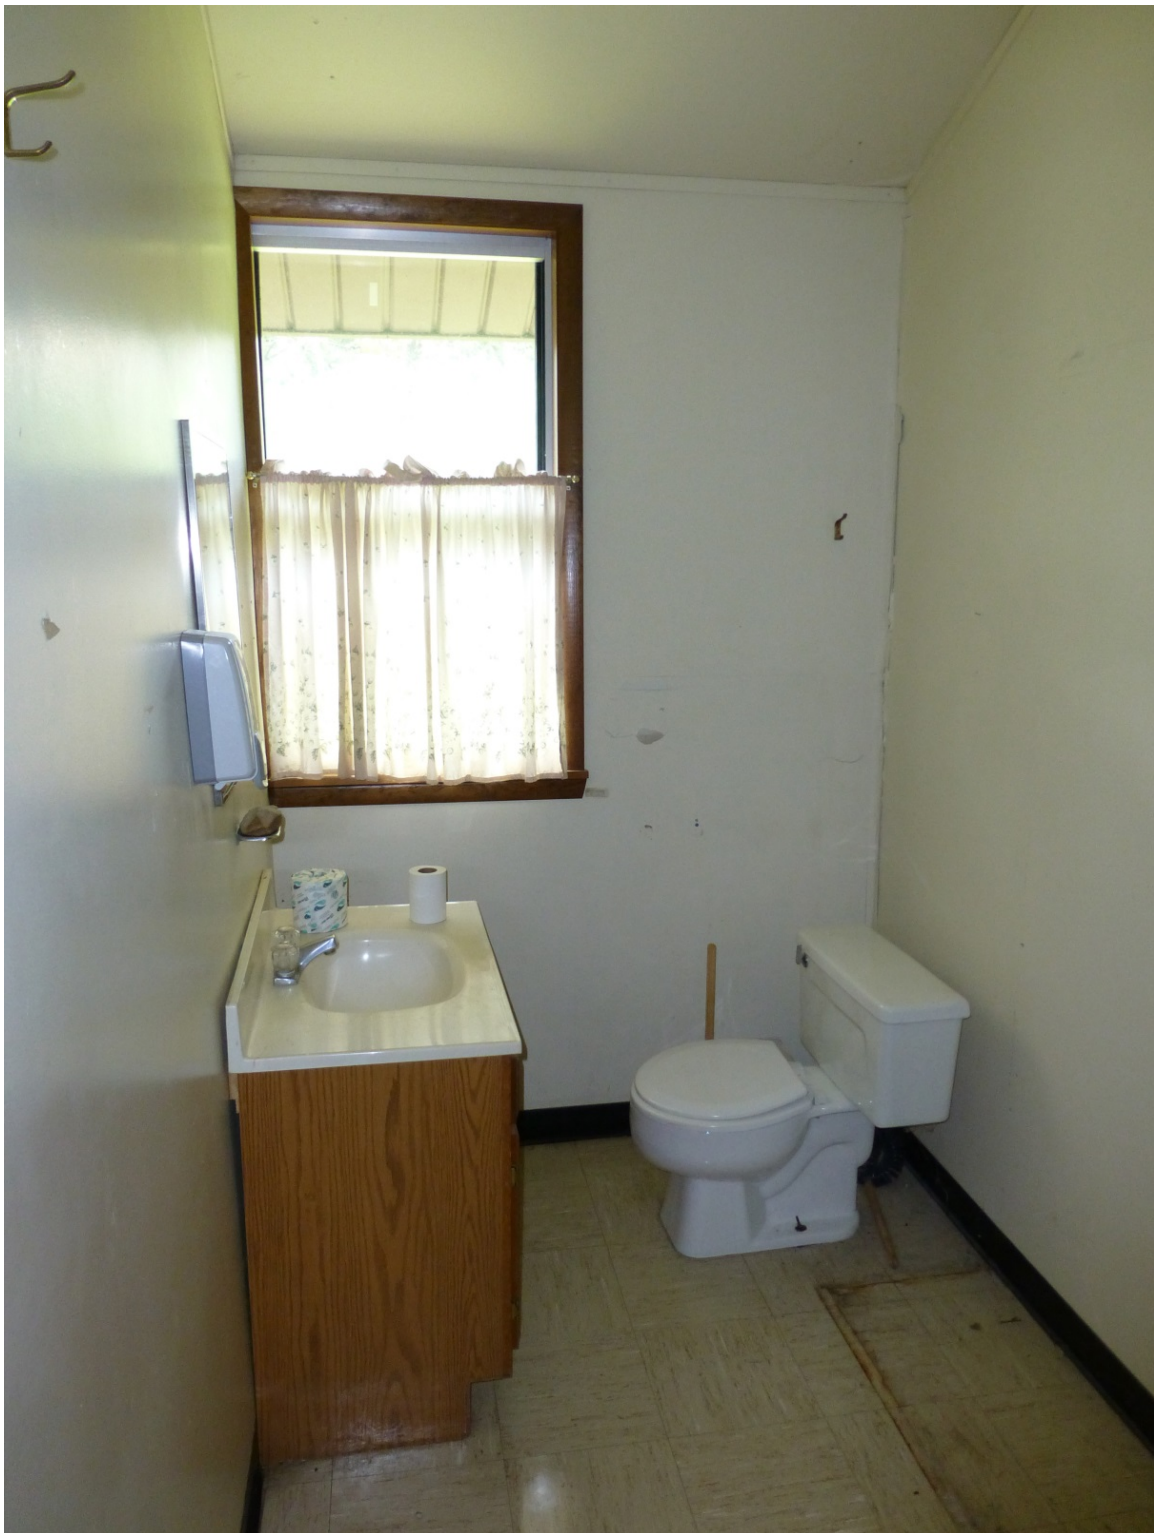
Figure 37. Non-original restroom in the northwest portion of the building (ERDC-CERL, 2013).

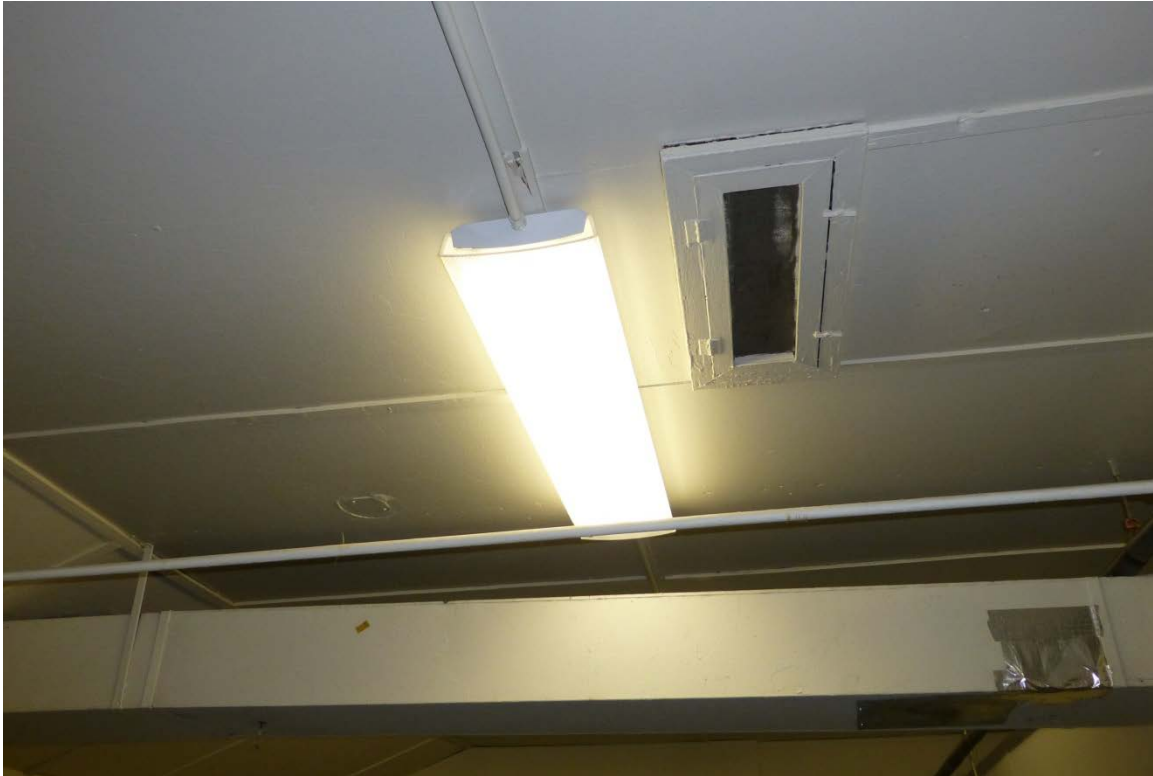
Figure 42. Example of non-historic fluorescent light fixture (ERDC-CERL, 2013).

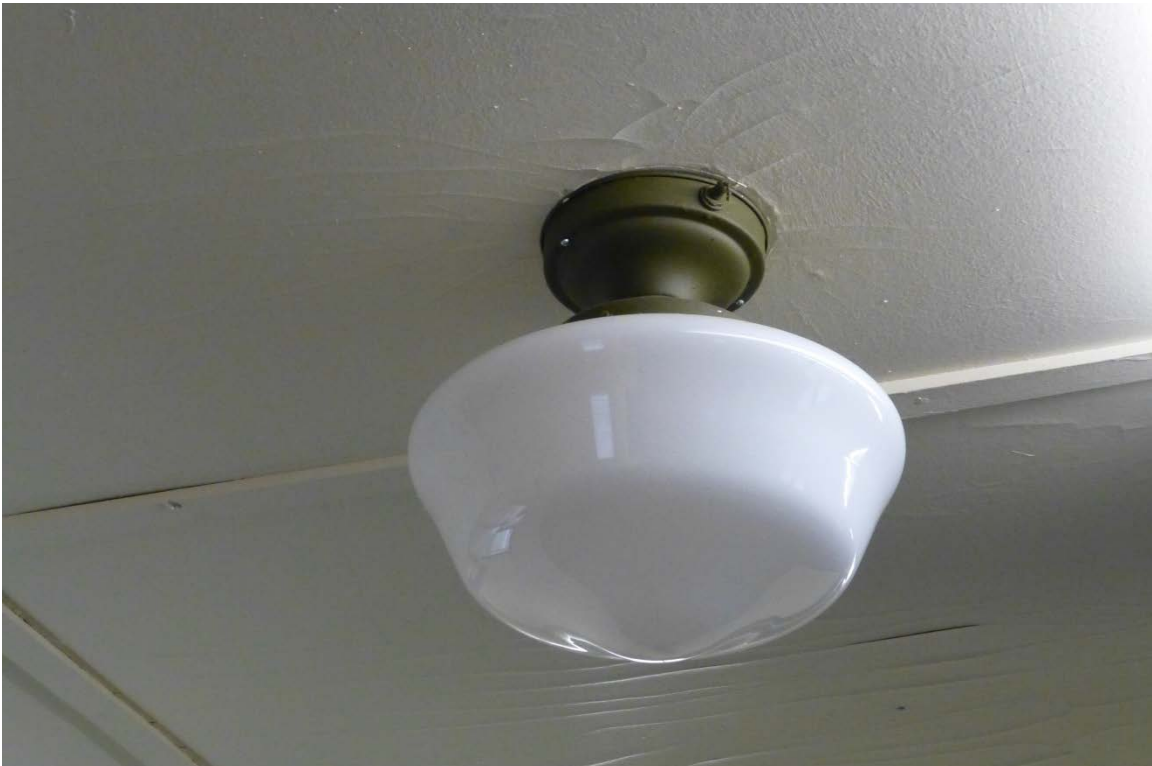
Figure 43. Retro schoolhouse light fixture placed on the ceiling of the ell (ERDC-CERL, 2013).

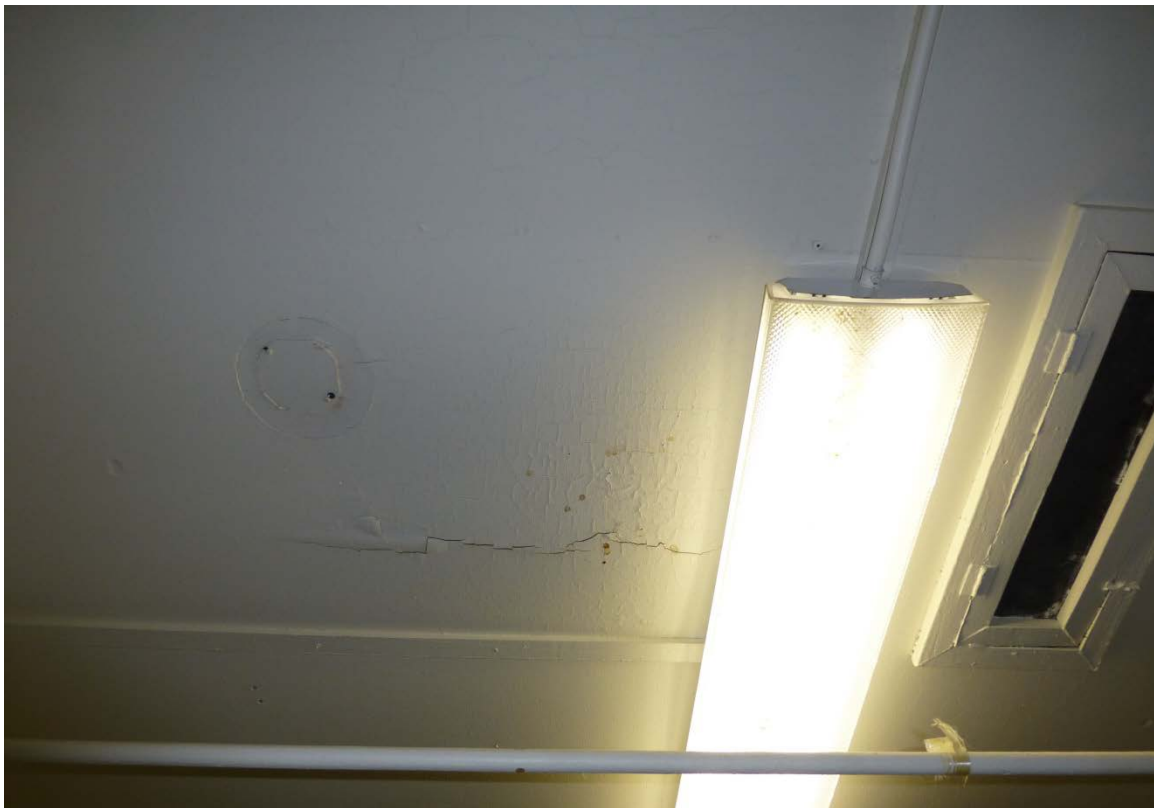
Figure 44. Example of an electrical box (center, left) marking the location of an original light fixture (ERDC-CERL, 2013).

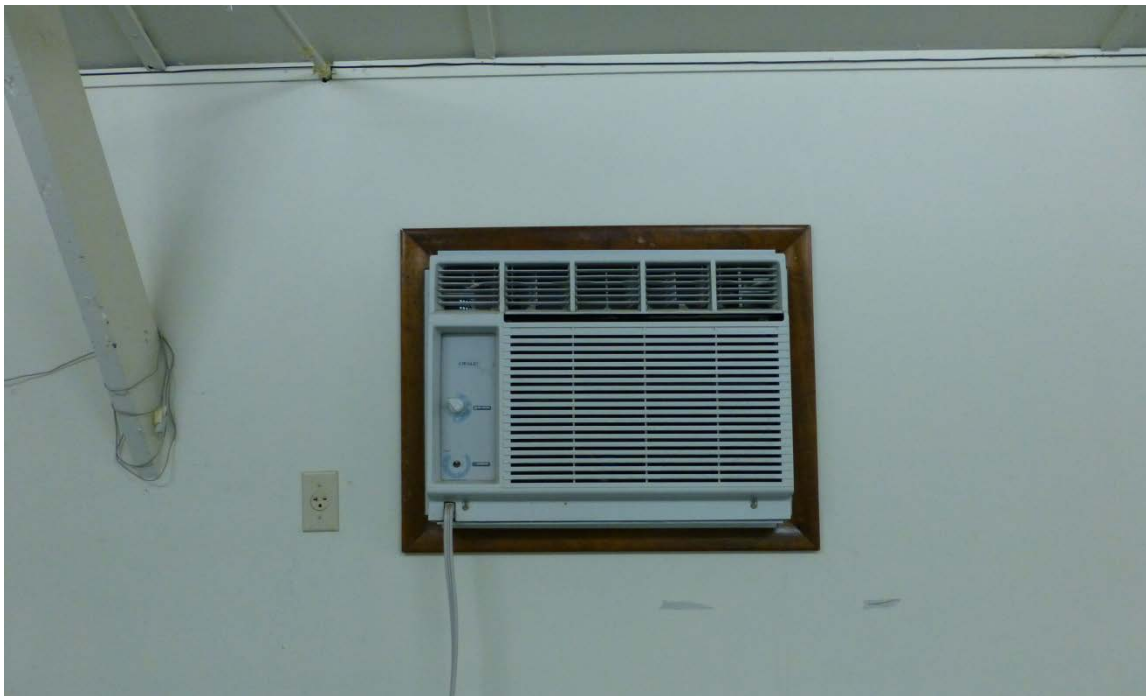
There are room-size air conditioners placed in wall openings cut for that purpose (e.g., Figure 45), and other wall openings where air conditioners once were located (e.g., Figure 46). None of these are original.

Figure 45. Air conditioner placed into an opening cut into the wall (ERDC-CERL, 2013).

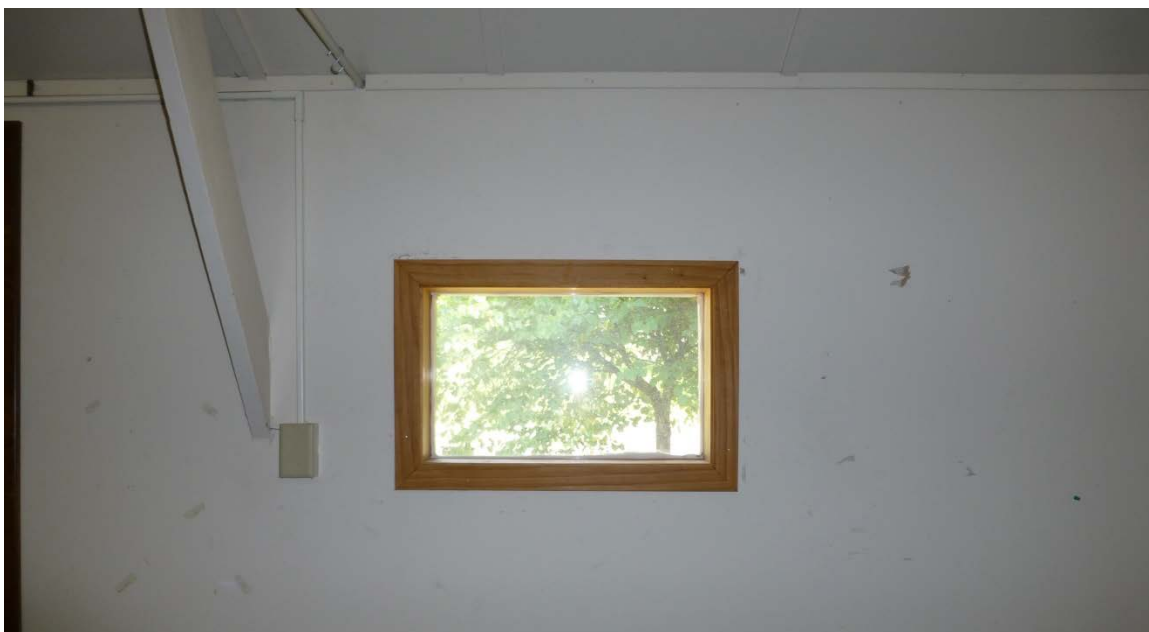
Figure 46. An opening for an air conditioner turned into a window (ERDC-CERL, 2013).
